Ergonomic Risk Reduction Method in Aerospace Manufacturing

Shigeshi Yamashita

Kodo Ito

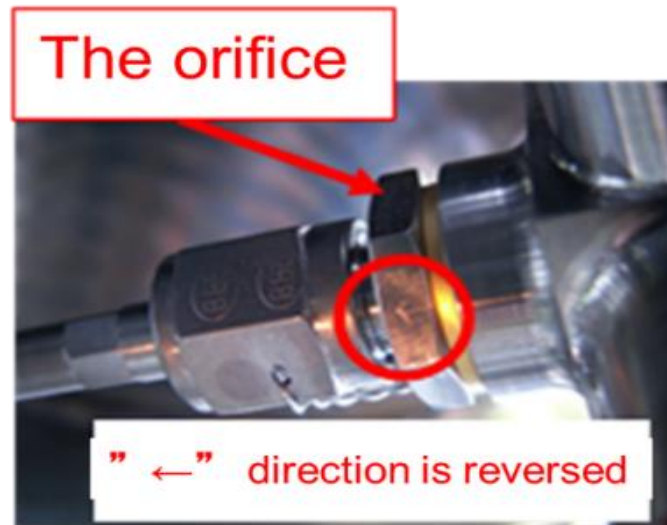
Figure 3. Orifice configuration.

The effectiveness of checklists was confirmed through the installation work of orifices to gas pipe assemblies of a space equipment. 2-3 skilled workers had to handle about 40 components, an inspector confirmed the work quality, and it took about 4 hours until the end of work. Because these orifices adjust the designated flow rate of liquid in the space equipment, they had to be installed to pipe assemblies in a prespecified direction. In the work, a nonconformity which orifices were installed to pipe assemblies in a wrong direction (Figure 3) was reported and it was identified as a human error. The investigation board conducted the “why-why analysis” based on interviews of skilled workers and derived following results.

Cause: Workers forgot to confirm directions of orifices after installation because they were worried about the back schedule of work.

Countermeasures: Reeducation of skilled workers to reconfirm the importance of fundamental safety procedure.

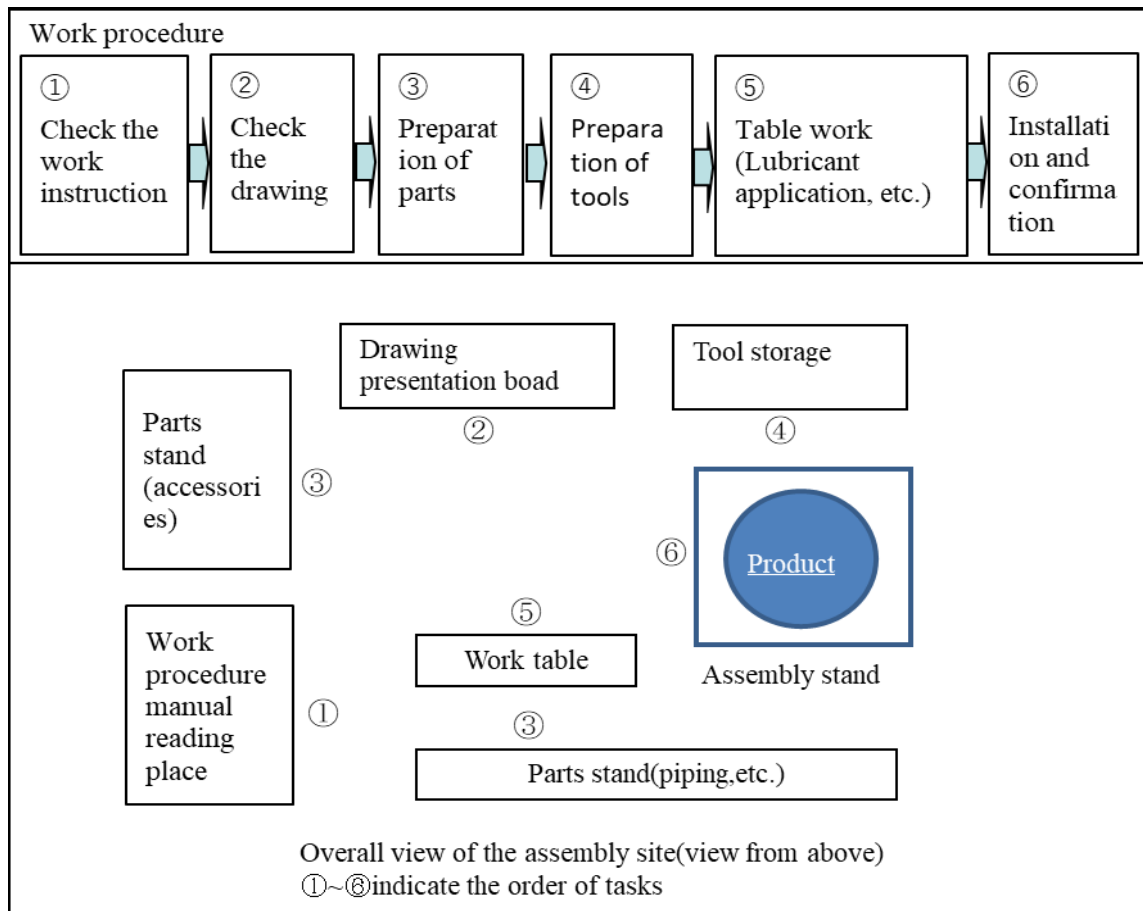
Figure 4. Gas piping system installation work outline.

- ①_The workers confirm the identification number of the orifices for installation and the tightening torque values which are specified in the work procedure manual.
- ②_The workers confirm the size of the orifice (flow path diameter) and the identification number of the seal from the drawing.
- ③_The workers bring the orifice and seals from the parts stand.
- ④_The workers bring the spanner and the torque wrench from the tool storage area.
- ⑤_The workers visually inspect the orifice thread, applies lubricant, sets the seal on the work desk.
- ⑥_The operator attaches the orifice to the pipe, tightens it to the specified torque, and checks the installation condition.

Although Figure 4 shows there is only one manual in a workplace, there are two to three workers there and they may wish to read the manual at the same time because details of work procedure are

When workers confirm their works by work procedure manual and the manual is difficult to use, workers tend to avoid checking their work procedures by manual because checking the contents of different distant pages by flipping through them is troublesome work, and the work procedure 1 in Figure 4 cannot be adhered to. Workers rely on their own memories when they install orifices and work procedures from 2 to 4 cannot be adhered to. The occurrence probability of wrong direction installation increases because the shapes of IN and OUT of orifices are the same and orifices can be installed to pipes in either direction.

When two to three workers may wish to read the manual at the same time, workers tend to avoid checking their work procedures by manual because they wish to avoid disturbing their workflows. The work procedure 1 in Figure 4 cannot be adhered to and work procedures from 2 to 4 cannot be adhered to because workers rely on their own memories, and the occurrence probability of wrong direction installation increases.

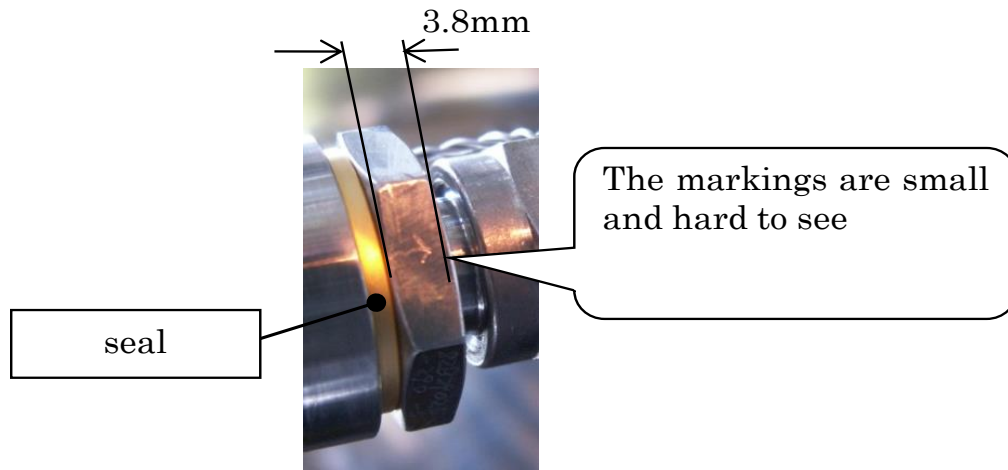
Figure 6. Orifice arrow marking.

Although there exists an arrow marking on orifice which is engraved by vibro pens in a space with 3.8 mm width (Figure 6), confirming the direction of orifice is difficult for workers because the arrow marking is small and is hard to identify. Furthermore, workers cannot see orifices directly and can verify arrow markings on them by using mirrors during assembling works because lots of gas pipes of a space equipment are interlaced complicatedly (Figure 7).

When confirming the direction of orifice is difficult for skilled workers, the misidentification of orifice direction occurs frequently, the work procedure 5 of Figure 4 cannot be adhered to, and the occurrence probability of wrong direction installation increases. Although seal is installed on the inlet side of the orifices to prevent external leakage from the joint after orifice installed, there exists a possibility that this seal may be pasted in the opposite position due to misidentification of arrow markings. Because this seal can be identified much easier than arrow markings, workers tend to judge mounting directions by seal and the occurrence probability of wrong direction installation increases.

Countermeasure of B: Add direction marks on orifices which can be easily identified visually by workers.

Because conventional arrow markings on orifices are hard to identify visually and cannot be identified when workers cannot see them directly during their works, new direction marks which have followed two differences are added (Figure 9).

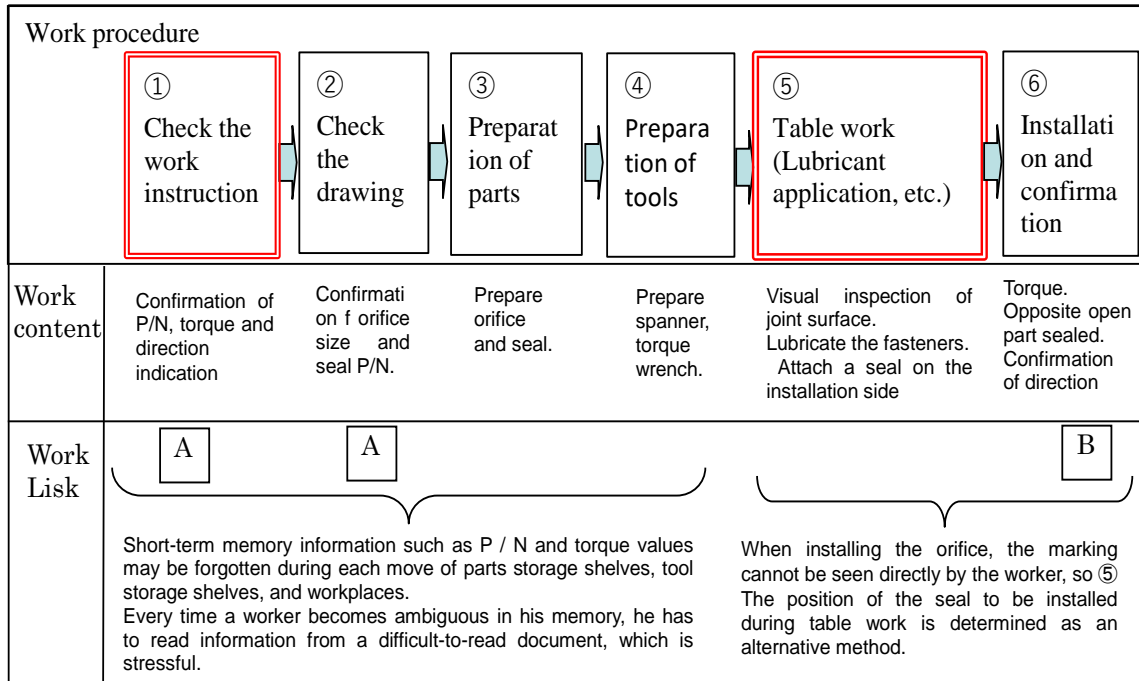
Figure 8. Work risks of skilled workers in orifice installation work.

Summarizing the above, following two misidentification risks during installation works which cause human errors due to the frustration avoidance behavior, are extracted:

- A: The misidentification risk which is caused by wrong memories of workers.
- B: The misidentification risk which is caused by wrong installed seal.

Following countermeasures for decreasing above two risks are proposed:

Countermeasure of A: Prepare a piece of paper which summarizes procedures and specifications for the installation work.
